Manhole Inspection Summary

Manhole # S25EE1013MH

Location Address: **1118 38TH ST**

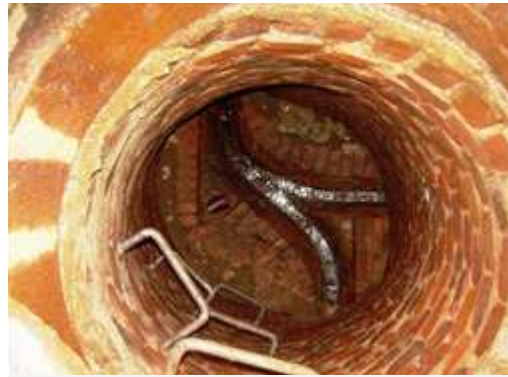
Top View

Evidence of surcharge - Bench debris.

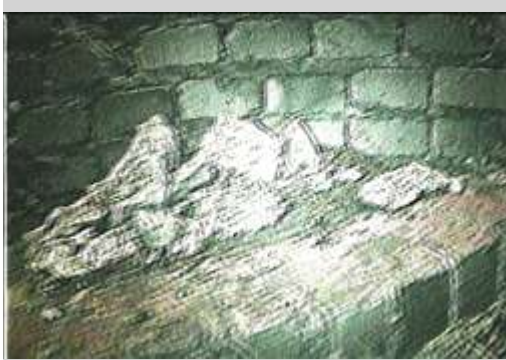
Defect

Barrel deterioration and infiltration. Bench debris.

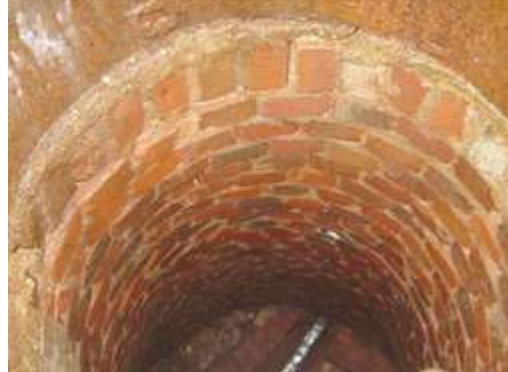
Defect

Frame leaks. Adjustment deterioration and infiltration - other side.

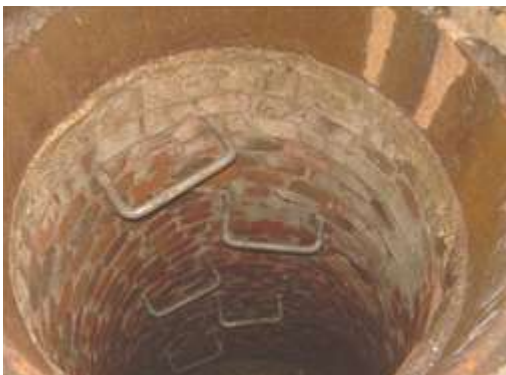
Defect

Frame leaks. Adjustment deterioration and infiltration.

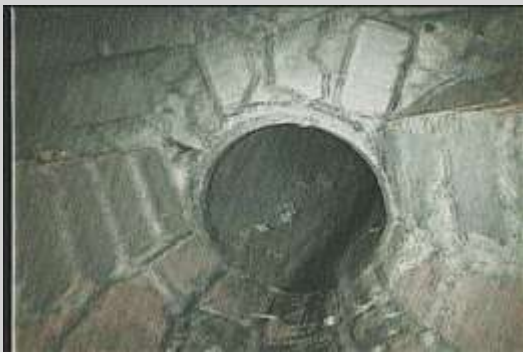
8 in. Circular Gravity Sewer Pipe Out @ 12 O'Clock

Infiltration: **None** Pipe Seal Cond: **Cracked**

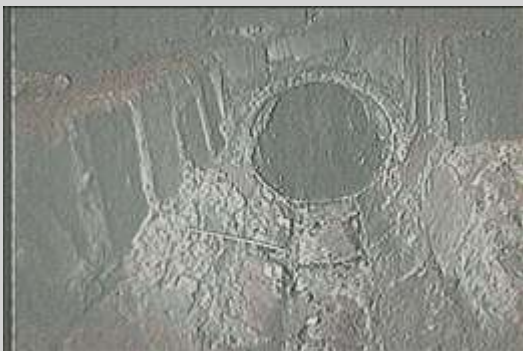
6 in. Circular Gravity Sewer Pipe In @ 3 O'Clock

Channel deterioration.

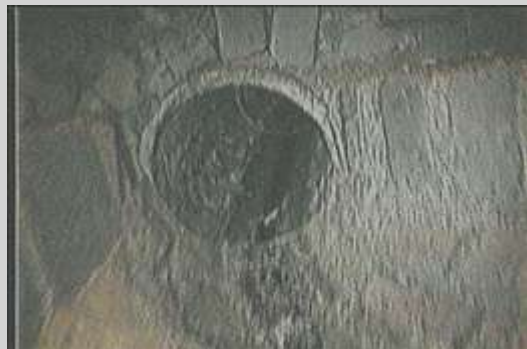
Pipe In @ 5 O'Clock

Deposits: ☐ None ☐ Mud ☐ Sludge ☐ Debris ☒ **Grease**

Deposits Extent: **Light**
